THE HANFORD SITE

Tank Integrity Program Update on SX Farm Tank Domes Under Observation

Washington River Protection Solutions

November 17, 2021

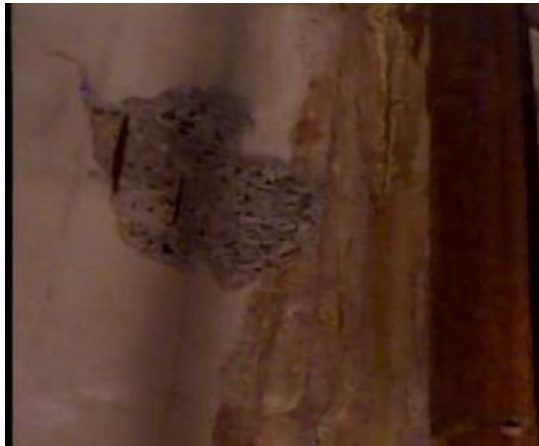
Area A

- 2/21/20: Visual inspection of three locations of spalling under observation
- 7/20/20 and 8/25/21: Visual inspections; areas of spalling did not change
- 9/9/21: Laser imaging inspection; areas of spalling with similar results

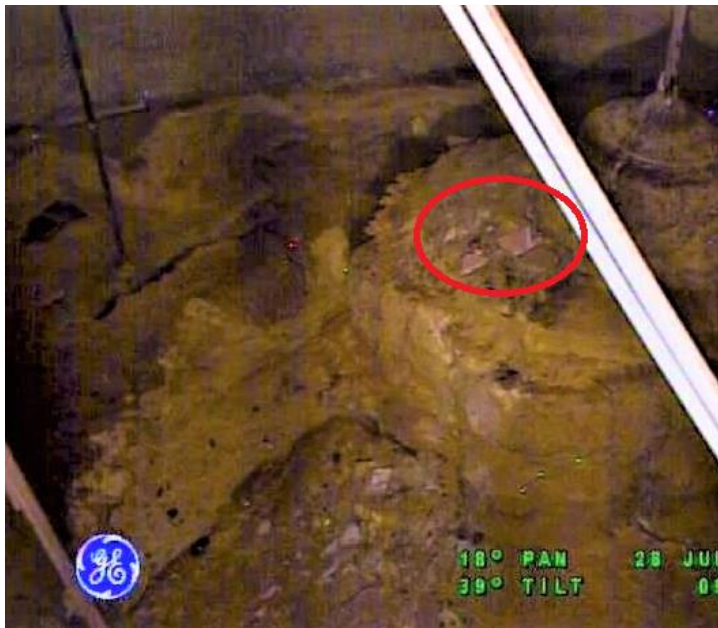
7/28/2020

- 7/28/20: Visual inspection of one location of spalling under observation (photo shows piece of spalled concrete on waste in the tank)
- 8/30/21: Visual inspection: area of spalling did not change

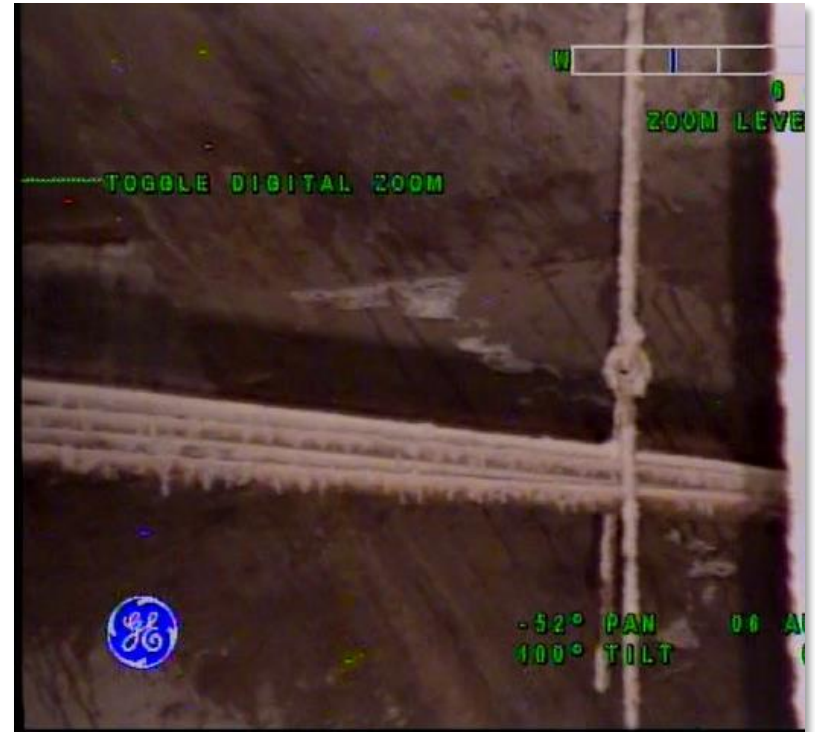
8/6/2020

- 8/6/20: Visual inspection of one location of spalling under observation
- No follow-up inspection needed in 2021

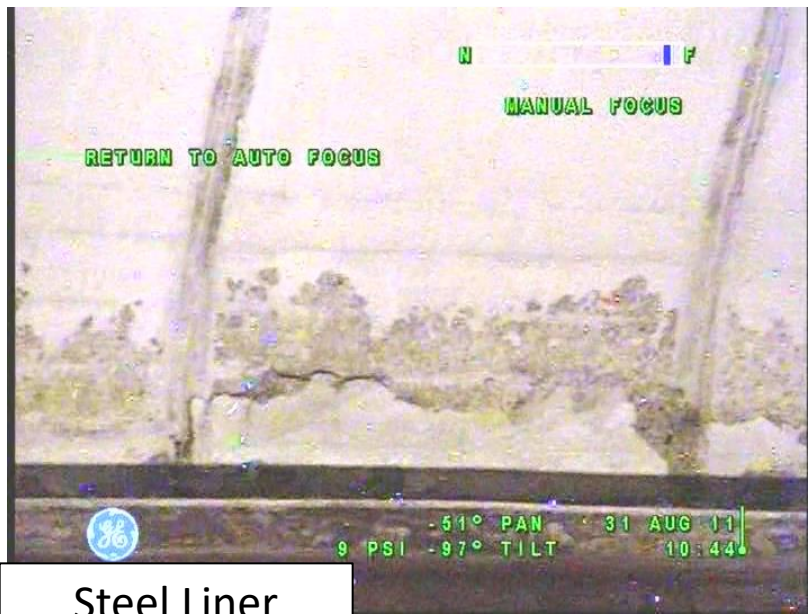
8/31/2011

- 8/31/11: Visual inspection of one location of spalling under observation
- 9/21/21: Visual inspection: area of spalling did not change

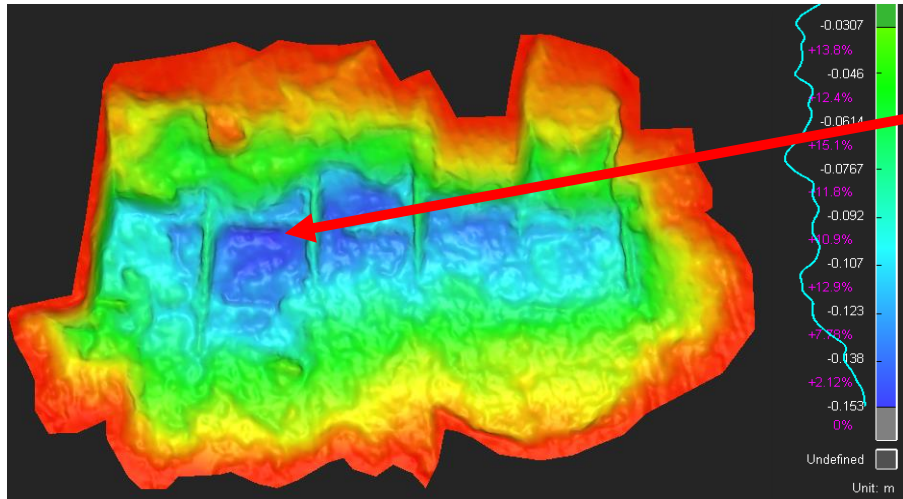
Spalling location on the dome

Max. spalling depth approx. 6 inches
